EVALUATION OF BAK-14 HOOK-CABLE
SUPPORT-SYSTEM MODIFICATIONS

FINAL REPORT

Test Period: 11 December 1974 - 31 July 1975

DDC 07
1-2
REPORT NATF-EN-1135

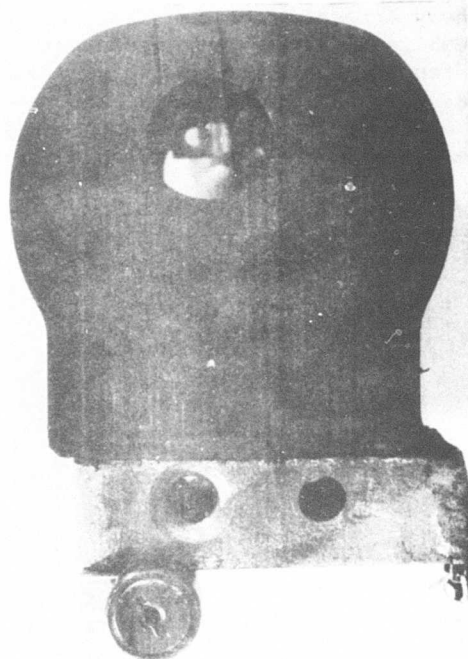
FIGURE 3 - SUPPORT BLOCK ASSEMBLY - BAK-14

a. SUPPORT-BLOCK ASSEMBLY, G&W PN 52-D-3247 (Figure 3): The hook-cable support-block assembly consists of a neoprene-rubber block that is molded with a metal frame in the base, and provided with a diagonal slot in the top for insertion and removal of the hook cable from the 1-3/8-inch-diameter retention hole in the block body. A shaft, inserted through the frame base of the block and through the support arm, anchors the block to the arm and allows the block to pivot about the shaft. The cam-plate rollers and extension springs which guide and aid in the pivot motion are attached to the base. When the system is lowered, the combined pivoting motion of the block and the arm results in an offset distance of approximately 4-5/8 inches between the raised position of the block (3-inch nominal hook-cable clearance above the runway) and the lowered position of the block (hook cable in the trough) (see Figure 4). The metal frame base of the block is also provided with a through hole to accept the nylon cord required to retain the hook cable in the blocks during cable dynamics caused by aircraft wheel tramples.

4. During the testing, three support blocks were sheared off at the base; two, by hook impacts of non-project aircraft when the hook cable was not installed on the BAK-14 support blocks and one, by extraction of the hook cable from a previously-weakened support by the arrested A-4 aircraft. No damage was sustained in the hook-cable retention area of the support blocks.

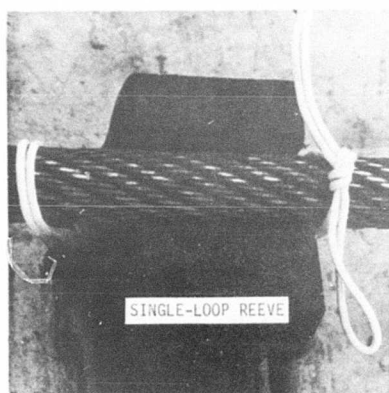
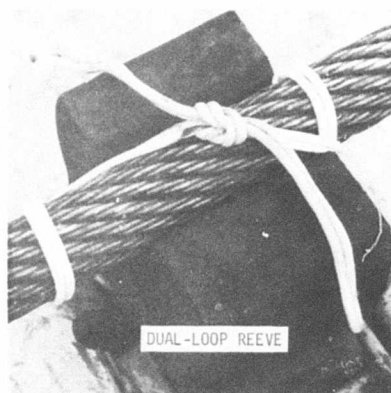
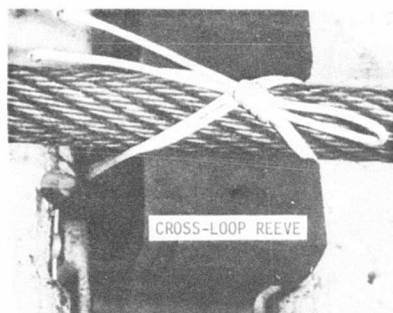
FIGURE 7 - THE STANDARD SINGLE-LOOP-REEVE, THE DUAL-LOOP-REEVE, AND THE CROSS-LOOP-REEVE RESTRAINTS

2. HOOK-CABLE RESTRAINTS (Figure 7): The nylon cords used to restrain the hook cable in the standard support block are reported to elongate and loosen when they become wet and are worn by chafing action of the support block, the hook cable, and the support-box cover. Because retention of the hook cable in the modified open-top support block is totally dependent on the effectiveness of the restraint, the development of an improved configuration was undertaken. The material used to fabricate the restraints was 7-foot lengths of nylon parachute cord (breaking strength - 500 pounds) 1/8-inch in diameter; either uncoated, or coated with one or two coats of GACO abrasive-resistant paint. The coating was applied by dipping and submerging the cord in the paint maintained at room temperature. All restraints were configured with the doubled nylon cord reeved through the anchor hole provided in the base of the support block and then around the hook cable where it was tied with a square knot. The three methods of reeving the doubled cord around the hook cable and upper portion of the support block were: the standard single-loop, the dual-loop, and the cross-loop reeves.

1. Restraints were slightly loosened and square knots were tightened by the hook-cable cycling.

2. No indication of restraint wear or damage was found.

G. HOOK-CABLE RESTRAINTS: The three hook-cable-restraint reeve methods tested were as follows: The standard single loop - 18 tramples; the dual loop - 30 tramples; and the cross loop - 77 tramples and 11 arrestments. Each reeve method was evaluated and the optimum method was selected in conjunction with the testing of support-block modification No. 1. The optimum was found to be the cross-loop reeve. Support block modifications No. 2, 3, and 4 and the standard support block were then tested with the cross-loop-reeve configuration. Uncoated and GACO-coated nylon-cord restraints were also evaluated.

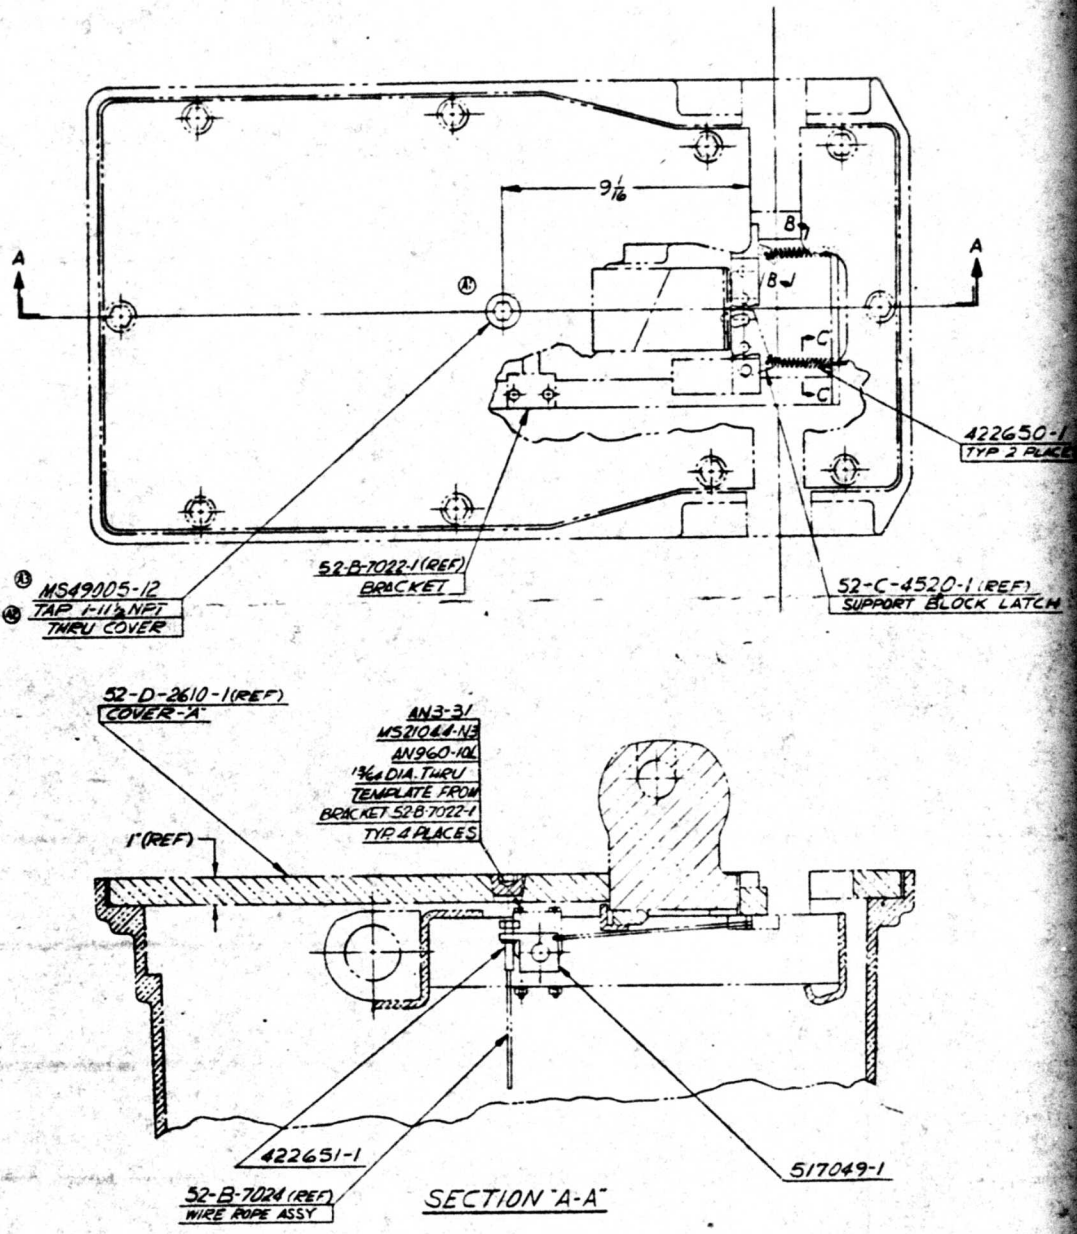
FIGURE 8 - INTERIM-LATCH-MECHANISM DESIGN

3. INTERIM LATCH MECHANISM (see Figure 8 at the back of this report): The interim latch mechanism was designed to provide a timely and effective remedy as soon as possible for the various discrepancies encountered with the standard latch mechanism during reference (f). The interim latch-mechanism design consists of the basic standard latch mechanism modified to provide additional features as follows:

H. INTERIM LATCH MECHANISM (see Figure 8): Interim latch mechanisms were installed in runway support boxes 4 and 5 (see Figure 1) for the 136 aircraft tests and the 100 cycle functional tests of the BAK-14 system. No problems were encountered with the latch springs, latch-spring anchor clips, pivot-shaft bracket anchors, or with the operation of the improved-access latch adjustment. Interference and installation problems were encountered with the pivot assembly, NAEC PN 517049, and the modified pivot assembly (Figure 15) as follows:
